# VEHICLE INSPECTION REPORT

**CV16XWG**

## Ford Transit 350 2.2 TDCI 155PS

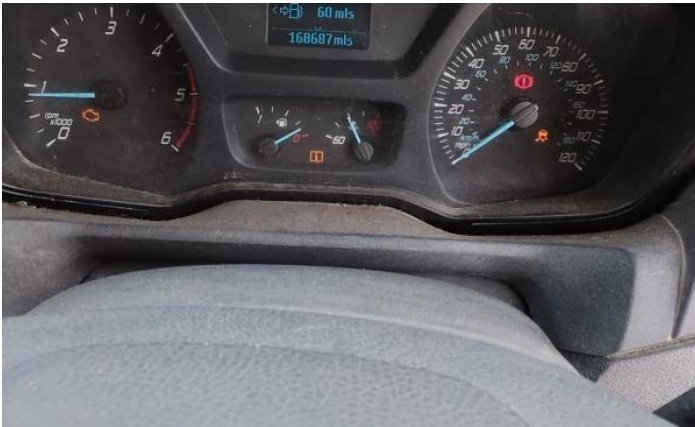
1: Dash Warning Lights  
Displayed  
No Action

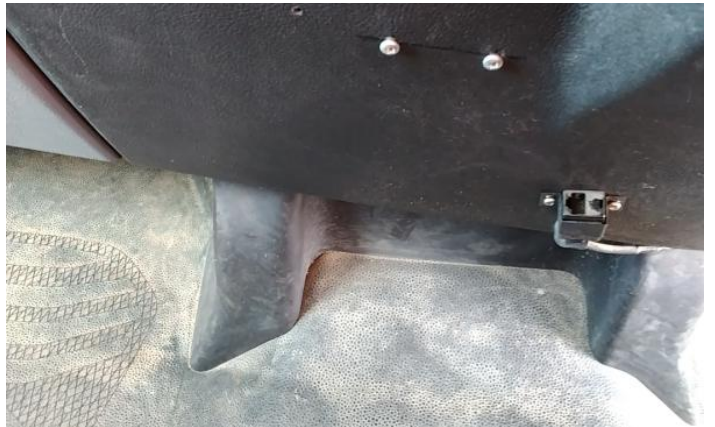
2: Centre Console Front  
Holed  
Over 3mm

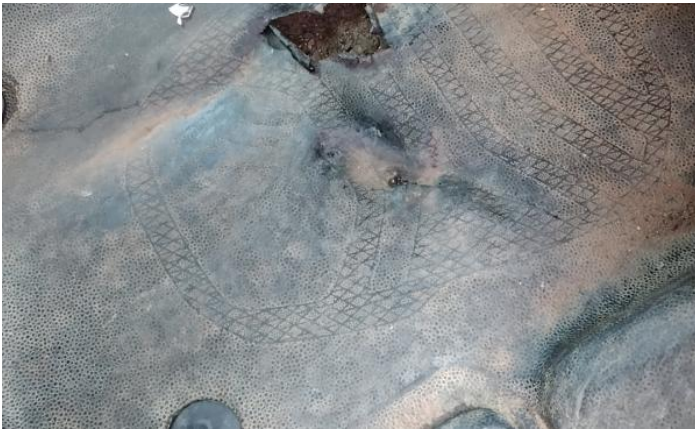
3: Carpets Front  
Holed  
Over 3mm

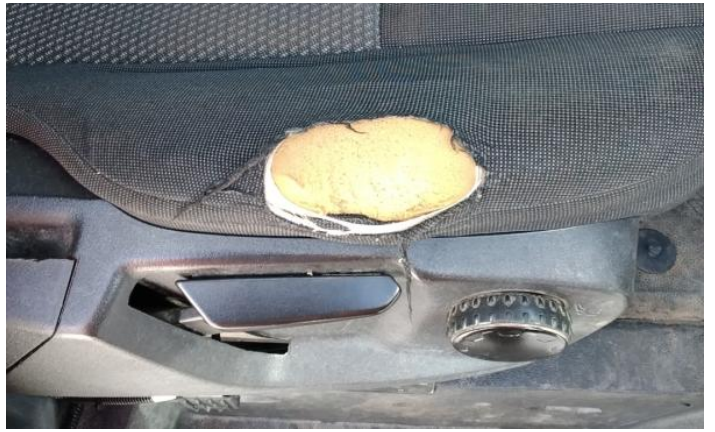
4: Seat Base Cover of  
Holed  
Over 3mm

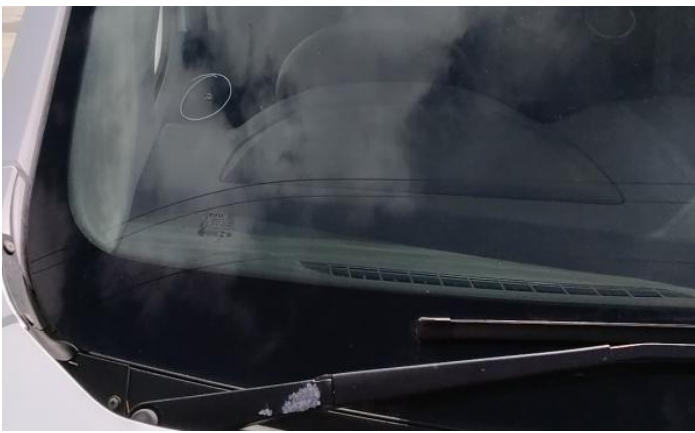
5: Screen Front  
Chipped  
Over 10mm

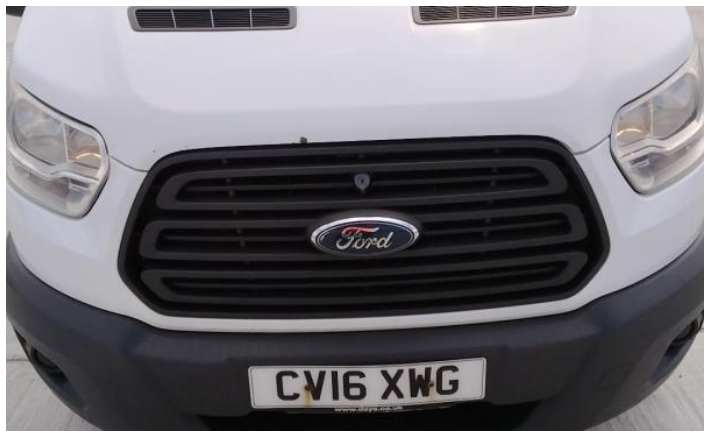
6: Bonnet  
Chipped  
Multiple Chips

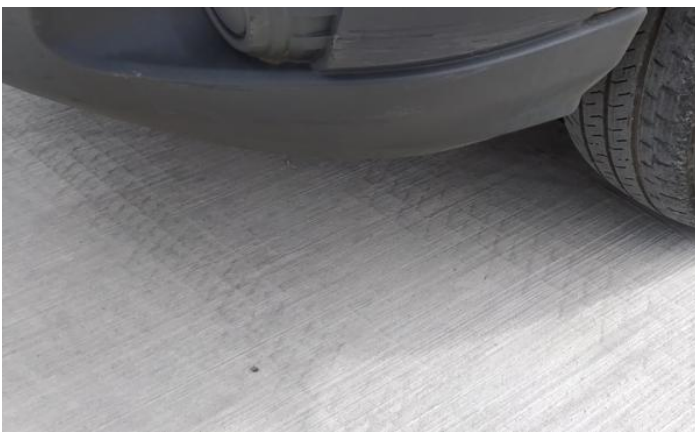
7: Bumper Front  
Scratched  
Over 100mm Thru Paint

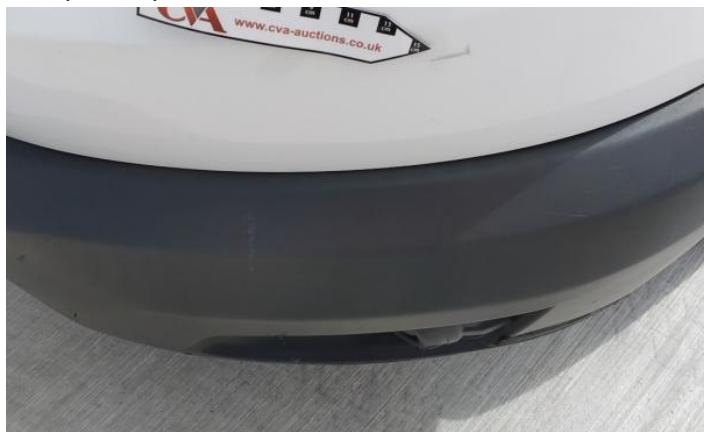
8: Bumper Front Moulding  
Scratched (Painted)  
Over 25mm Thru Paint

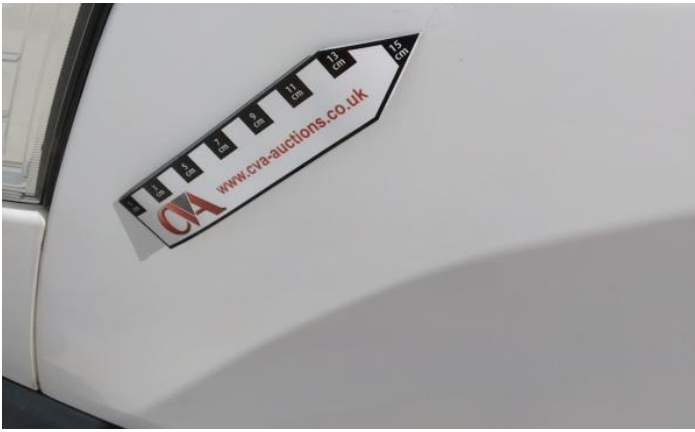
9: Wing nsf  
Scratched  
Over 25mm Thru Paint

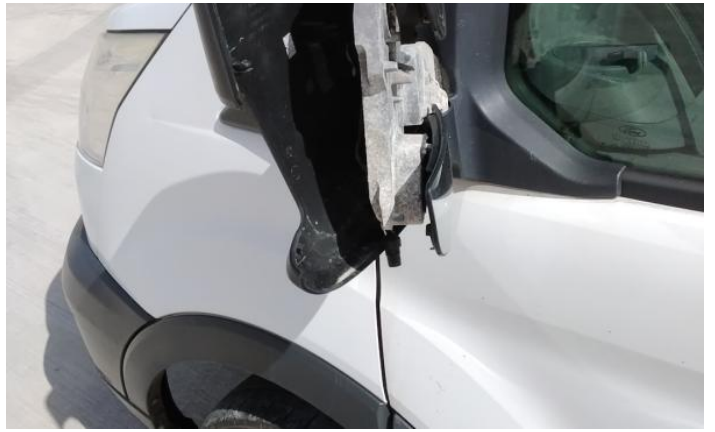
10: Door Mirror Assy nsf  
Broken  
Replace

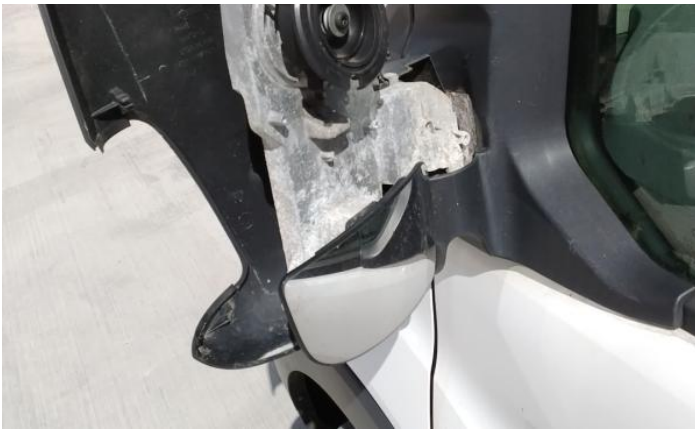
11: Door Mirror Glass ns  
Missing  
Replace

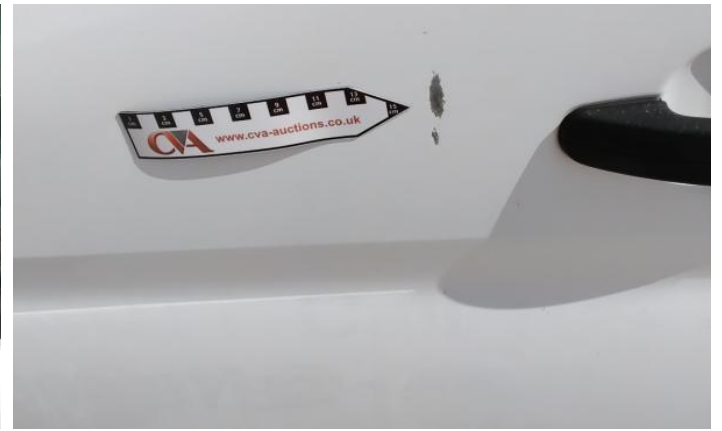
12: Door nsf  
Scratched  
Over 25mm Thru Paint

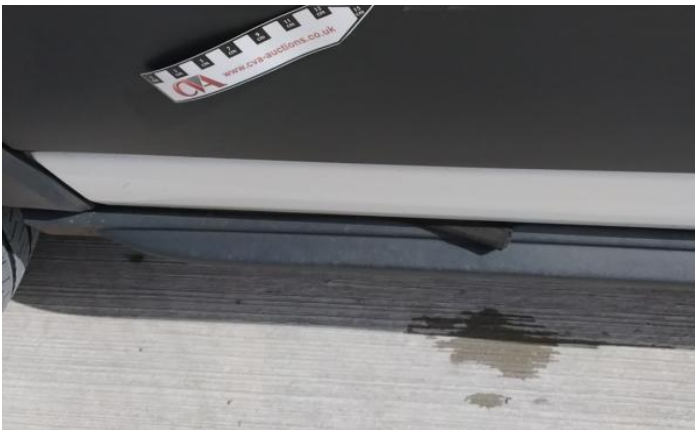
13: Door Moulding nsf  
Scratched (Painted)  
UpTo 25mm Thru Paint

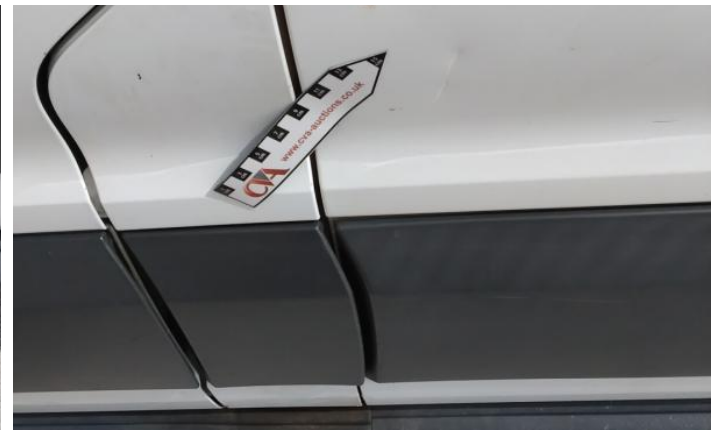
14: Qtr Panel nsr  
Scratched  
Over 25mm Thru Paint

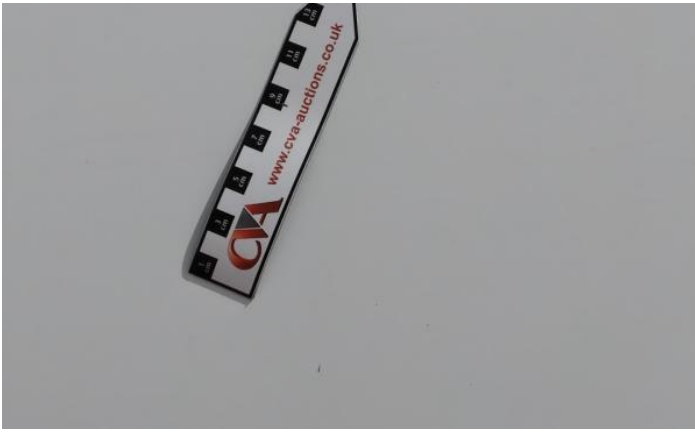
15: Qtr Panel nsr  
Scratched  
Over 25mm Thru Paint

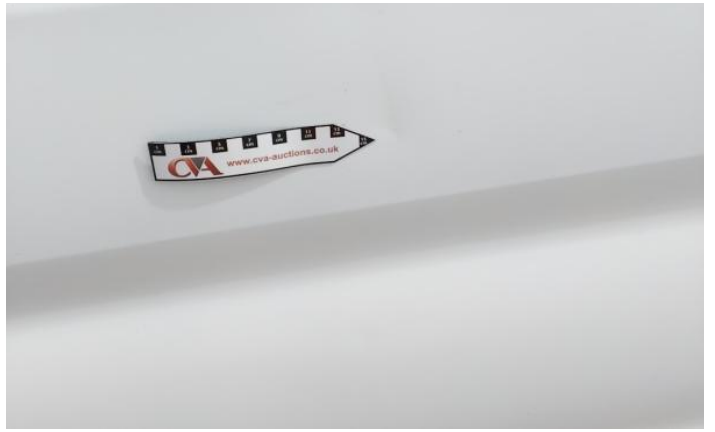
16: Qtr Panel nsr  
Dented  
Over 30mm

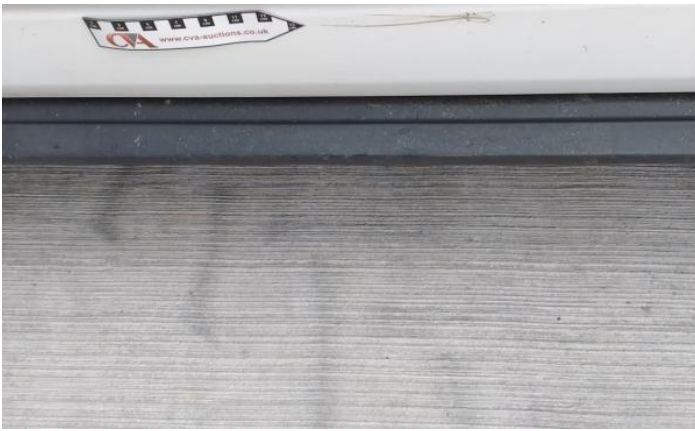
17: Qtr Panel nsr  
Scratched  
Over 25mm Thru Paint

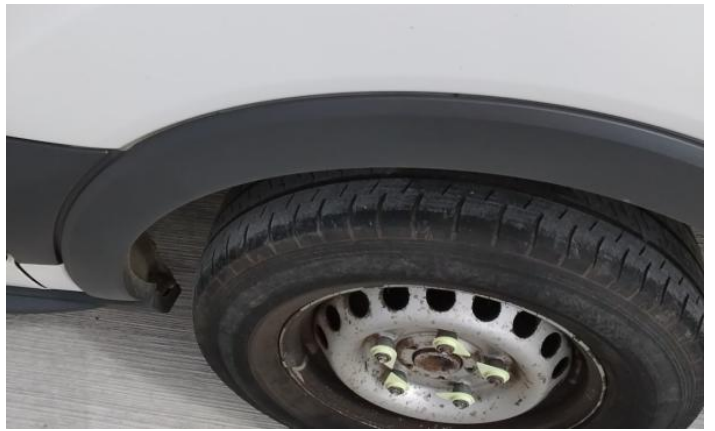
18: Qtr Panel nsr  
Scratched  
Over 25mm Not Thru Paint

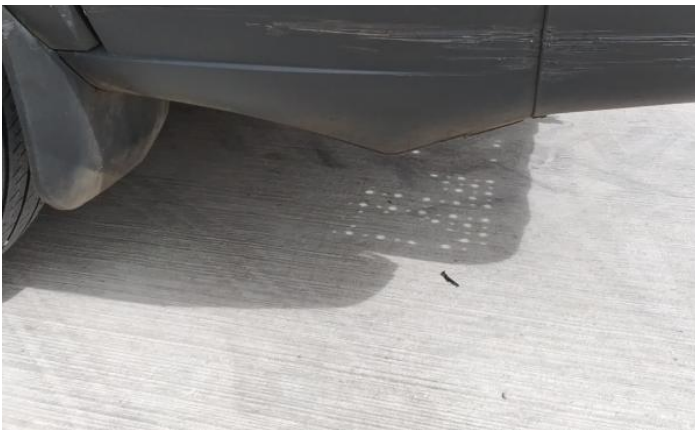
19: Bumper Rear  
Scratched  
Over 100mm Thru Paint

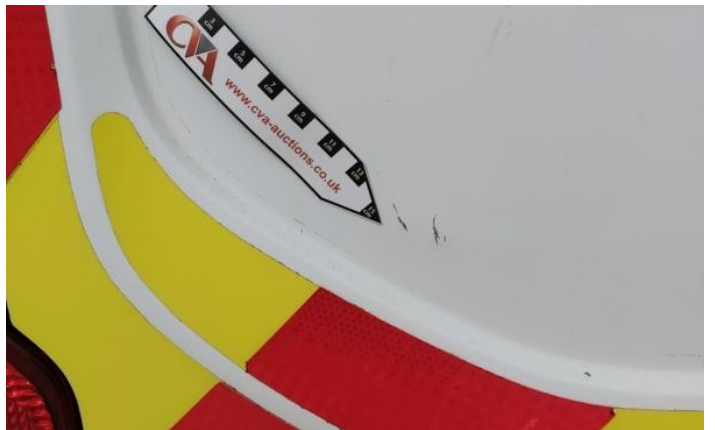
20: Door nsr  
Dented  
With Paint Damage

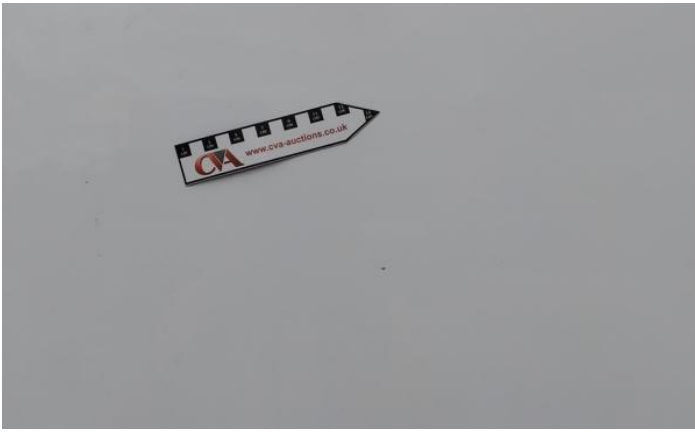
21: Door osr  
Dented  
Between 10mm + 30mm

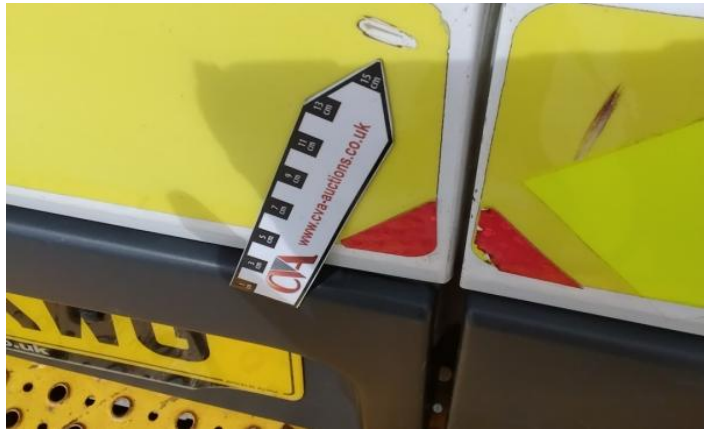
22: Door osr  
Scratched  
Up To 25mm Thru Paint

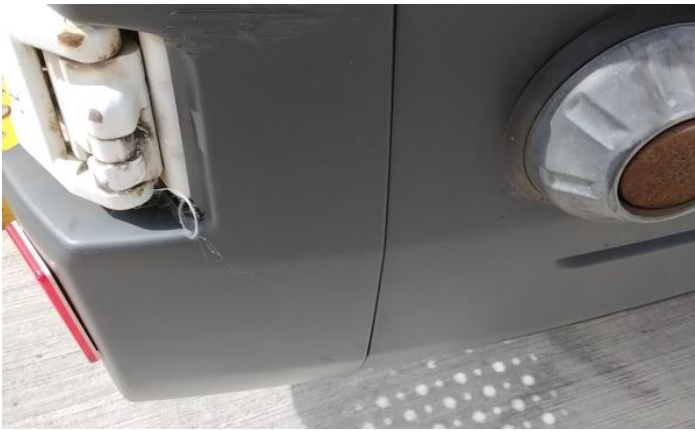
23: Bumper Rear  
Scratched  
25 to 100mm Thru Paint

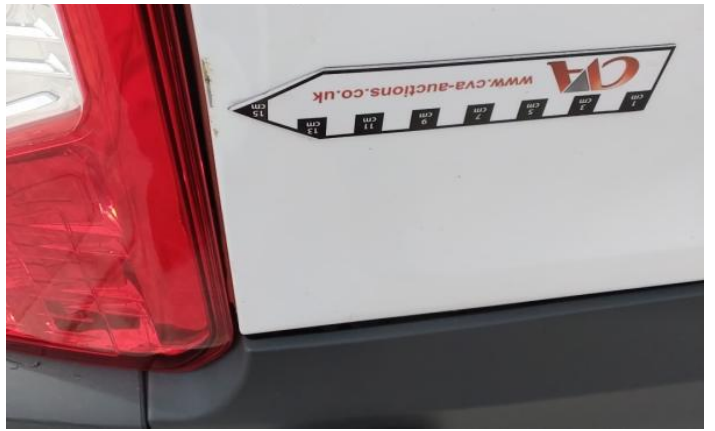
24: Qtr Panel osr  
Dented  
With Paint Damage

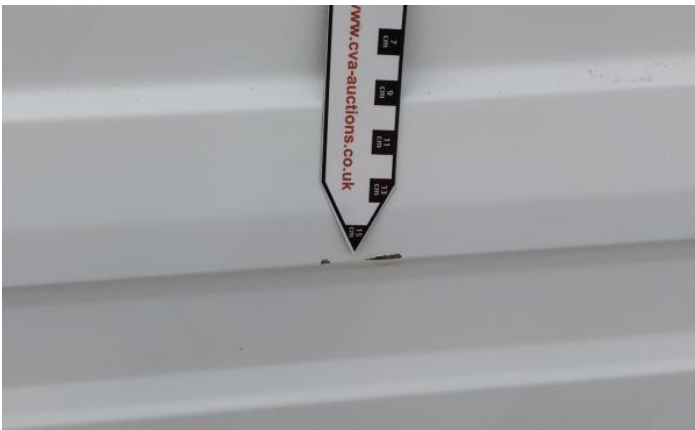
25: Qtr Panel osr  
Scratched  
Over 25mm Thru Paint

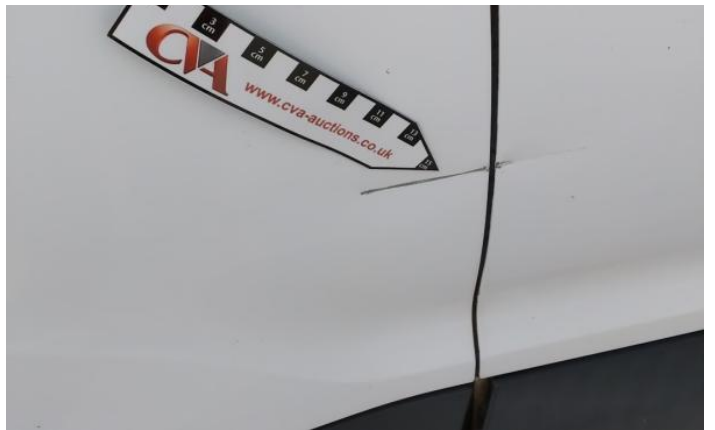
26: Qtr Panel osr  
Scratched  
Over 25mm Thru Paint

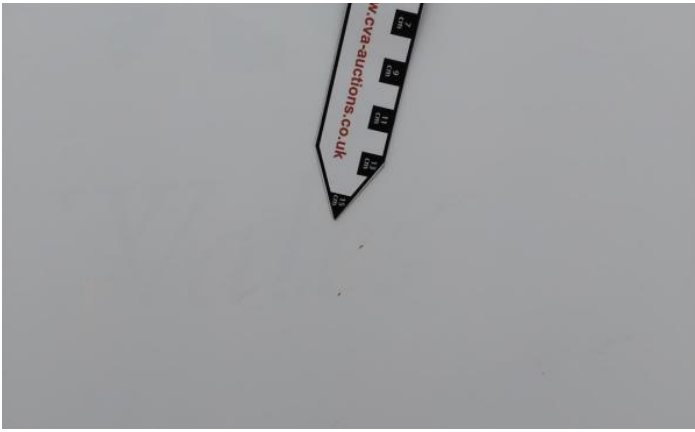
27: Qtr Panel osr  
Scratched  
Over 25mm Thru Paint

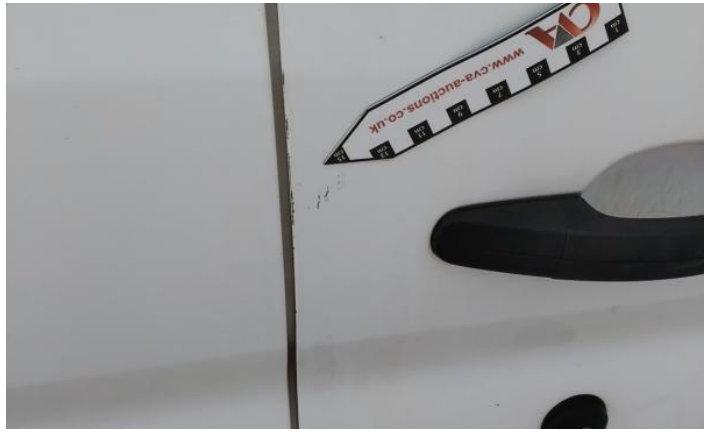
28: Door osf  
Chipped  
Multiple Chips

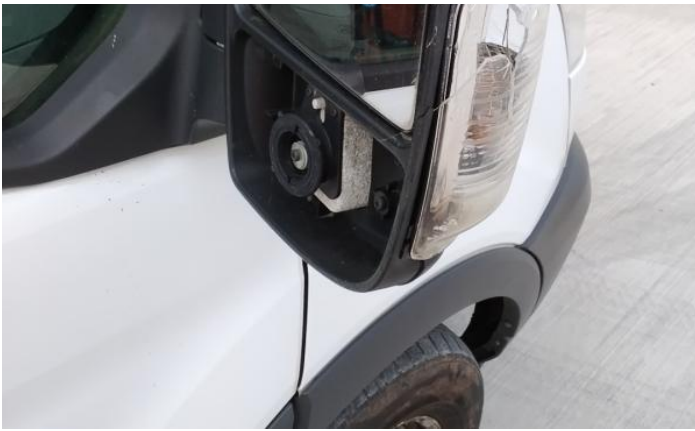
29: Door Mirror Glass os  
Broken  
Replace

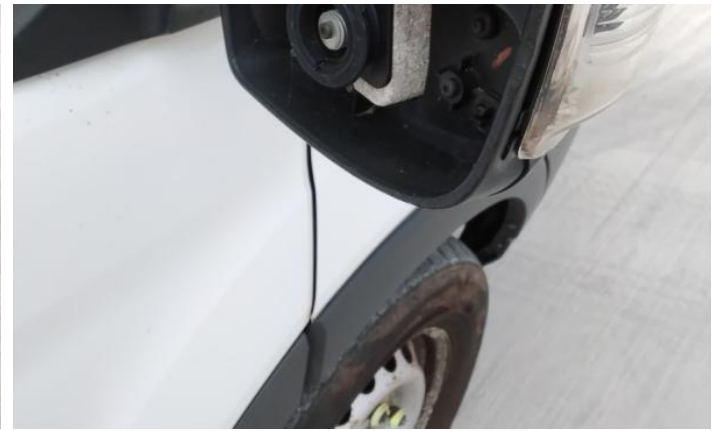
30: Door Mirror Glass os  
Missing  
Replace

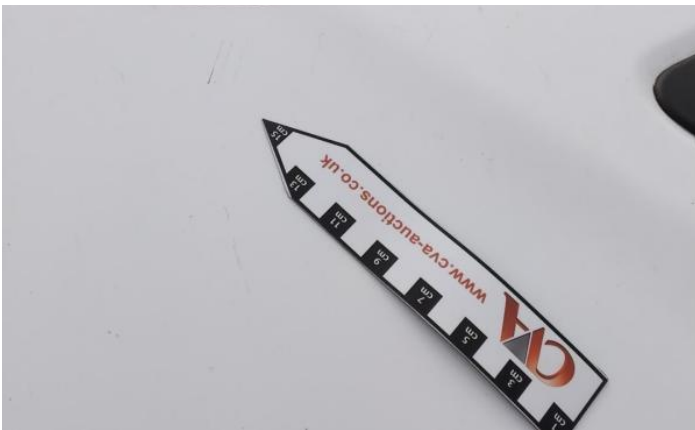
31: Bonnet  
Scratched  
Over 25mm Thru Paint

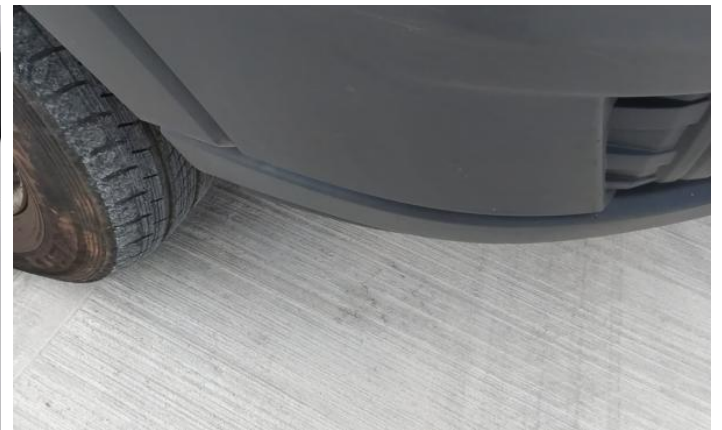
32: Bumper Front  
Scratched  
Over 100mm Thru Paint
